Bohdan Demchyna¹, Leonid Vozniuk², Mykhaylo Surmai¹

CONDITIONS OF EXISTING RESIDENTIAL BUILDINGS 50–60 YEARS AND MISTAKES OF THEIR CONSTRUCTION

Lviv Polytechnic National University,

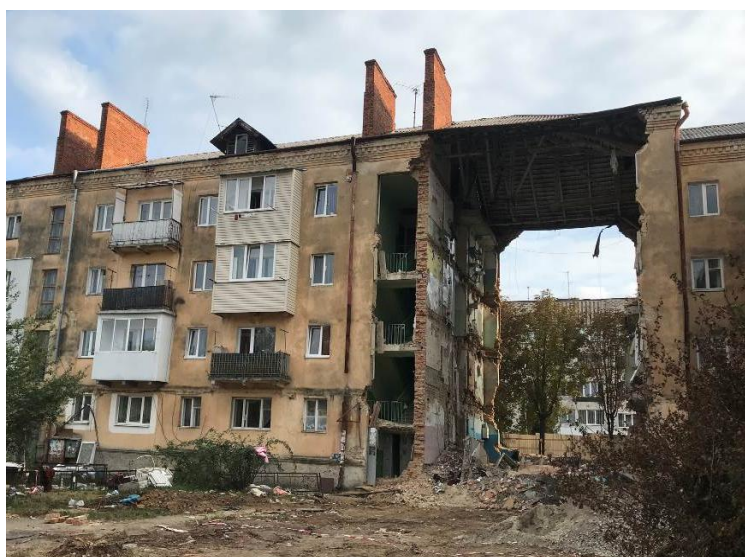
- collapse of building structures of a part of a building of all 4 floors (Fig. 2);
- basement walls and basement walls, no waterproofing;
- visible loss of stability of the middle bearing wall of the basement, vertical cracks in the wall with opening up to 10 mm in height of the bearing brick wall with the destruction of the masonry (Fig. 3). No brickwork of the basement walls. Wrapping of walls, vysolyas, fungus damage, destruction of bricks, as well as weathering and loss of strength of seam solution;

Fig. 2. The collapse of part of the building

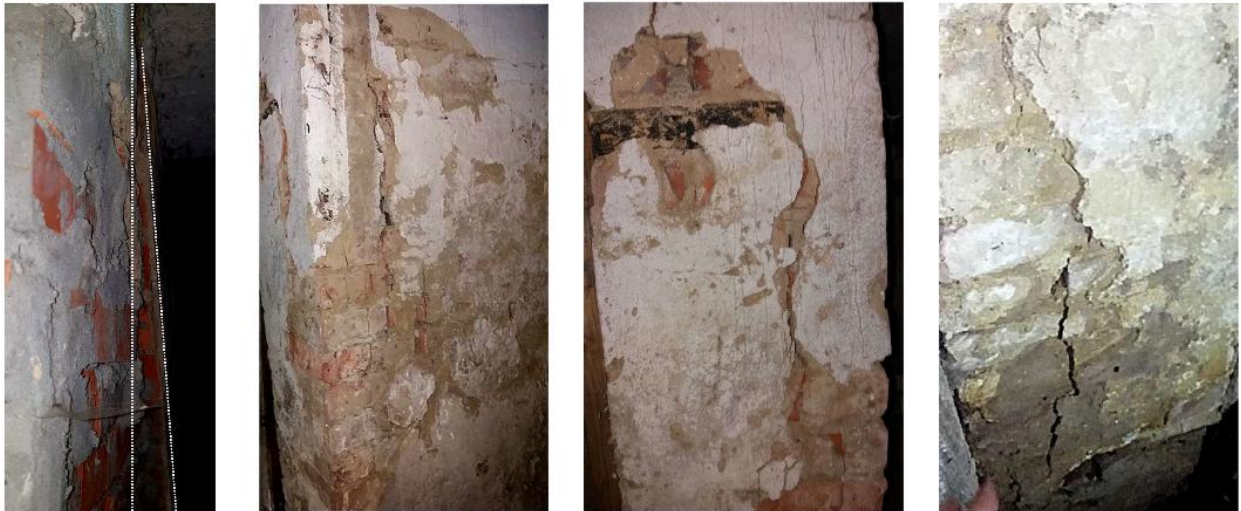
Fig. 3. Visible loss of resistance, as well as vertical and horizontal cracks in the middle bearing wall on axis B in axes 6–8

– lack of drainage and waterproofing in the examined building. Executed engineering-geological surveys have shown that during the period of intense atmospheric precipitation or melting of the snow cover a temporary water horizon of type “top” can be formed on the soils of IGE-2 (loam semi-solid), which could lead to flooding of the house, so during construction it was necessary to provide measures for drainage of the territory and waterproofing of the foundations, which was not done during the construction of the building;

– low grade of brick and mortar, which is confirmed by laboratory tests.

As can be seen from the calculations – the compression stresses that occur in the walls of the middle bearing wall of the right side of the building, along the axis B in the axes 6–8, significantly exceed the bearing capacity of the brickwork. This phenomenon is also confirmed by the results of the survey of the building where the emergency walls were identified (Fig. 3).

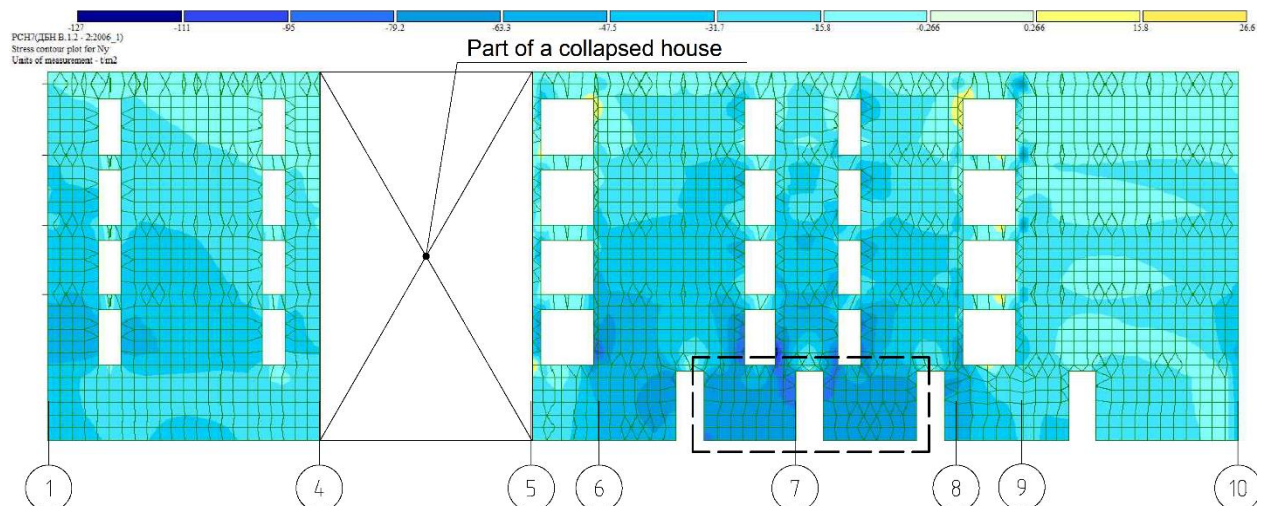
Fig. 4. The distribution of stresses in the middle bearing walls along the axis B, in the axes 1–10, after the collapse

The selected walls in Fig. 4 basement floors along axis B, axes 6–7, 7–8 are fragmented and analyzed further in Fig. 5.

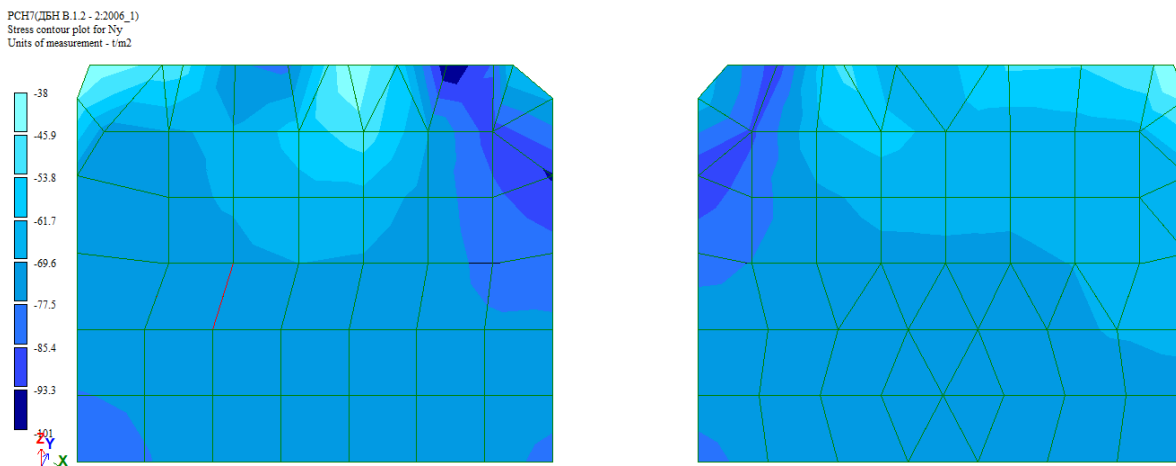
Fig. 5. Distribution of stresses in the basement walls of the right part of the building along axis B, in axes 6–7 and 7–8

The maximum stresses in the basement walls along axis B, in the axes 6–7, 7–8 exceed the allowable values of compressive strength of masonry $R = 29,56 \text{ t/m}^2$.

$$N_y = -38 \dots 101 \text{ t/m}^2 > R = 29.56 \text{ t/m}^2.$$

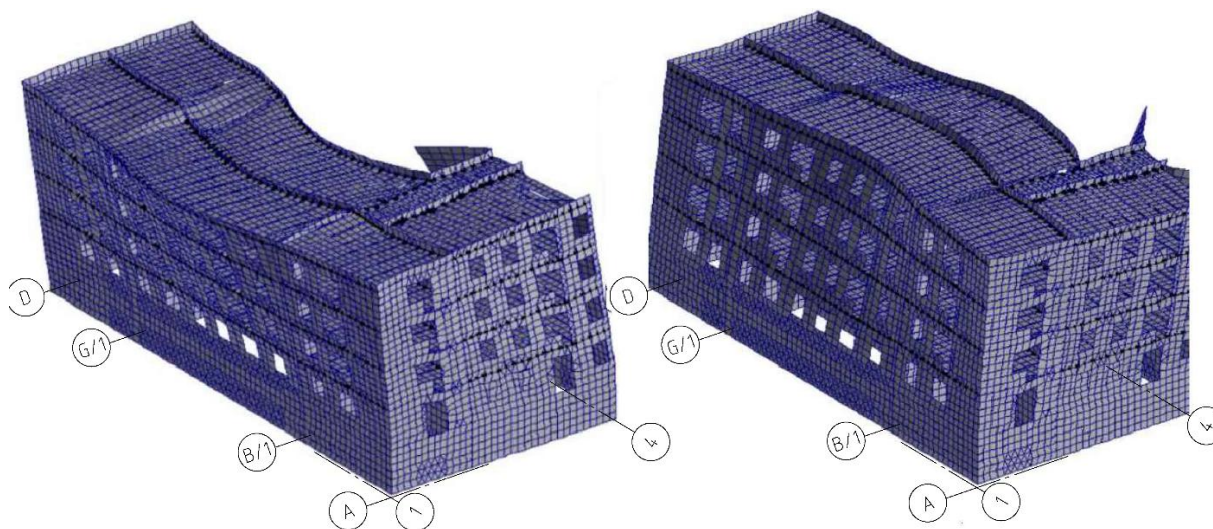
To analyze the possible impact of the collapse on a part of the building, in axes 1–3, AD, a dynamic calculation was made of the possible impulse that caused the collapse, which allowed to obtain the character of the movement of the building structures from fluctuations, in particular in Fig. 6 shows the nature of the movement from the 2nd translational form of oscillations.

Fig. 6. The nature of the movement of building structures of the left part of the house after the collapse of the 2nd translational oscillation

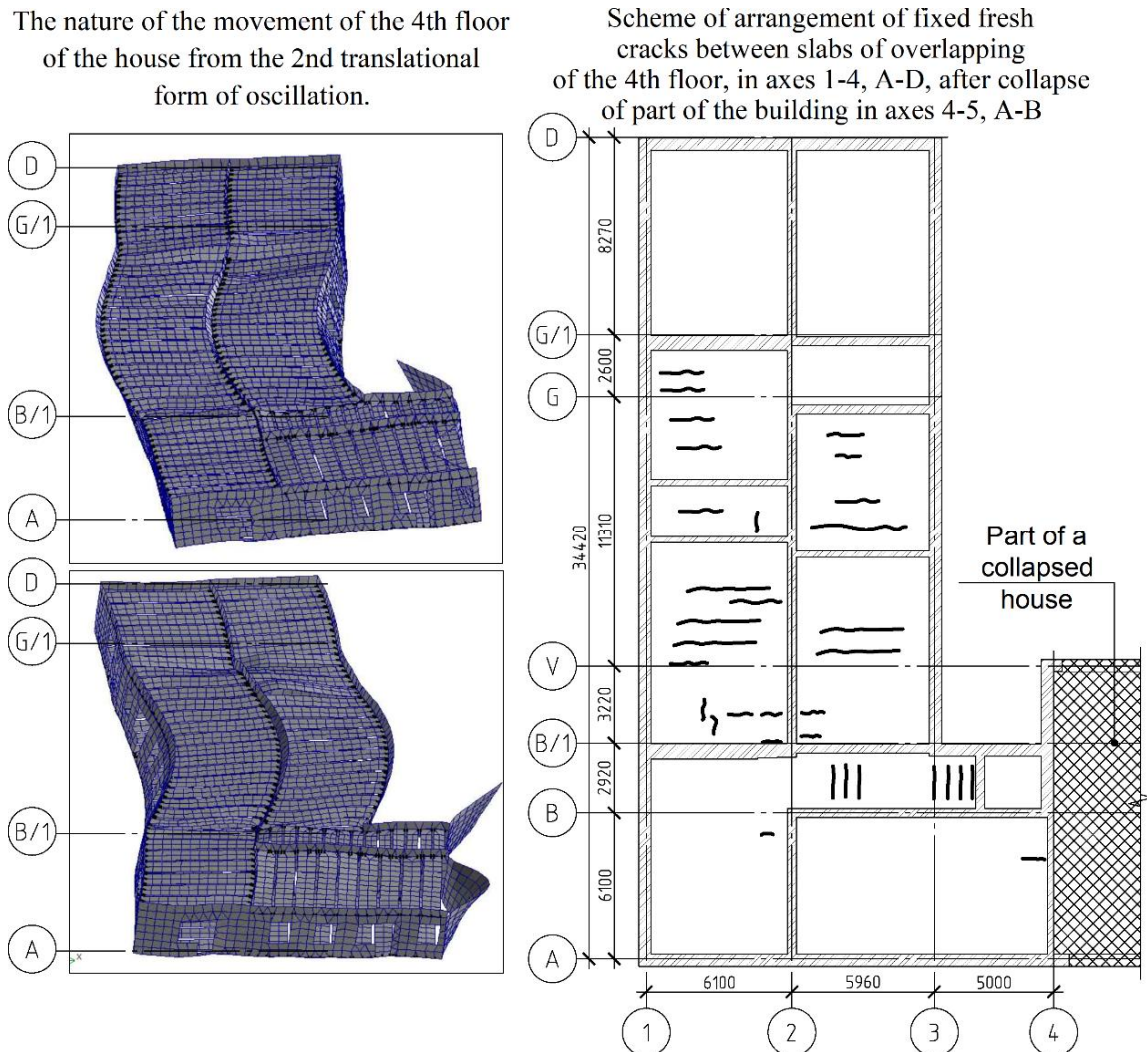
Such character of displacements is confirmed by the results of the survey presented on the scheme of location of defects with fixed fresh cracks between slabs of overlapping and at the top of partitions at the junction with the overlapping disk of the 4th floor of the left part of the building (Fig. 7).

Fig. 7. Comparison of the nature of the movement of the building structures of the left part of the house after the collapse from the 2nd translational oscillation with the actual placement of fresh cracks formed after the collapse of part of the building

Throughout the building, there are cracks under the floor slabs in the ceiling, as well as fresh cracks between the seams of the floor slabs, indicating the movement and disturbance of the flooring discs due to the impact caused by the collapse of the structures in axes 4–5, AB. These defects were further confirmed by the results of the dynamic calculation, using the finite element method in the PC “Monomakh-SAPR”, which allowed to obtain a similar nature of the movement of the overlapping disks of the building.
