EMERGENCY CONDITION OF LOGGIAS IN BUILDINGS WITH SUPPORTING BRICK WALLS

A real example of such a problem in the existing 9-storey building with brick load-bearing walls, where the shortcomings of construction were manifested, namely the poor quality of masonry at the junction of loggias to the load-bearing walls of the building.

All these construction errors, individually or in combination, often lead to damage or destruction of the load-bearing structures of loggias, which, in turn, makes the building an emergency. An example of such a situation is the condition of loggias in an existing building with load-bearing brick walls on the street. Volodymyra Velykoho, 44 in the city of Lviv.

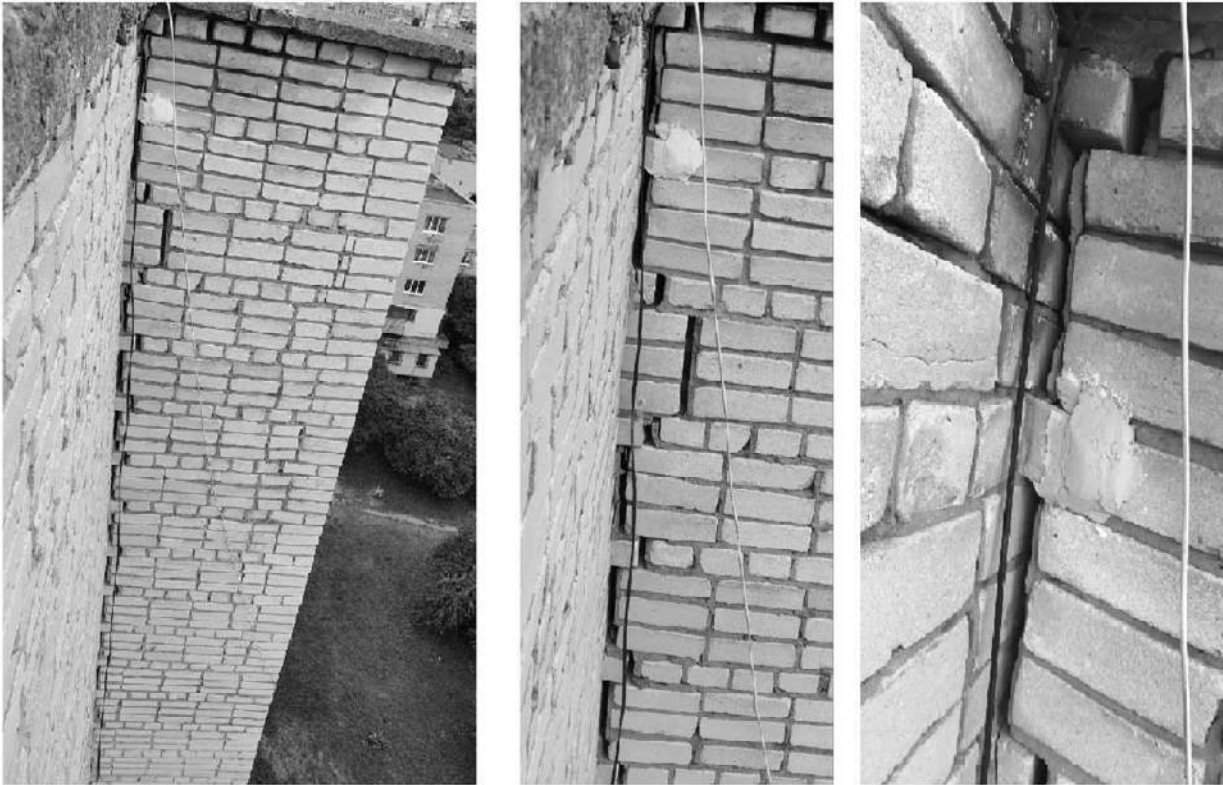
Fig. 2. Vertical crack at the junction of load-bearing walls and loggia

In (Fig. 2) you can see a vertical crack in the height of the building, the width of which is greatest at the highest point of the building and reaches 40 mm. The crack is mainly in height between the rows of masonry, but there are also cracks in the body of the brick in a row, which serves as a link between the wall of the loggia and the load-bearing wall of the building.

The brickwork of the loggia is three-row with a bandage in one row, which connects the loggia with the perpendicular load-bearing wall of the house. Prefabricated ribbed reinforced concrete floor slabs rest on the end bearing load-bearing brick walls of the loggia and are not attached to the building. This means that the connection of the loggia with the house is solved by only one row of masonry, which is nested in height in three rows.

After the formation of a through crack at the height of the building, the loggia begins to work as a free-standing part, respectively, there is a danger of its destruction.

Based on a visual inspection of the visible part of the building structures and the results of calculations, it can be concluded that the cause of cracks is poor quality masonry load-bearing walls of the loggia and load-bearing walls of the building, which caused an emergency condition of the building.

This situation requires fencing of the area near the loggia, a ban on residents to go to the loggia and the urgent development of a project to strengthen building structures to eliminate the emergency situation.

Reinforcement of the considered building structures can be made of metal structures, namely clamps and straps, which should connect the structure of the loggia with the load-bearing wall of the

building. When implementing the reinforcement project, it is necessary to take into account all regulations in force at the moment.

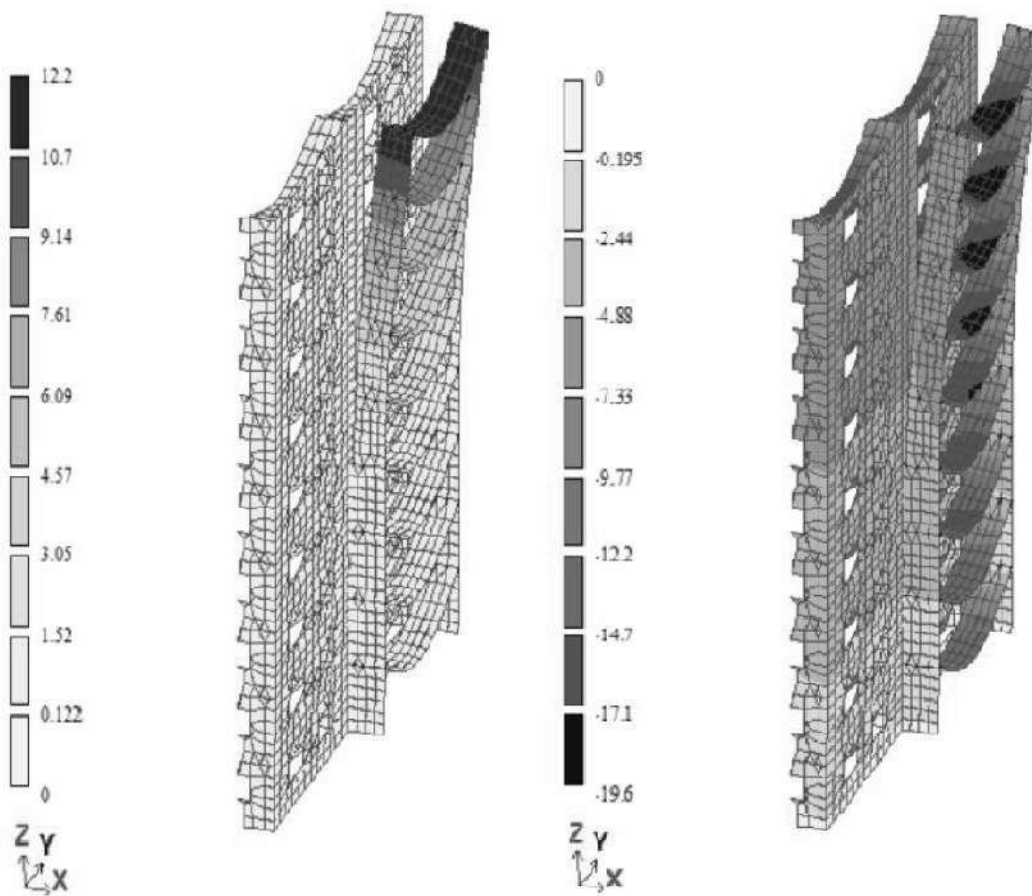
Fig. 3. Isopolies of loggia displacements along X (horizontal component, mm) and Z (vertical component, mm)

To better understand the operation of the structure after the formation of cracks and taking into account its structural scheme and white loading, a calculated finite element model was created in the PC "LIRA-CAD" and the movement of the loggia was obtained (Fig. 3).

The structure of the loggia is designed so that the loads are unevenly distributed, namely on the outside (from the side of the facade) enclosing reinforced concrete panels and glazing create a running load, which causes skew of the loggia structure, because it is not attached to the building properly.

To obtain a more accurate reproduction of the existing structure of the loggia, after the formation of through cracks, in the calculation scheme between the outer load-bearing wall of the building and the 5 upper floors was modeled deformation seam (at this height visually visible crack opening).

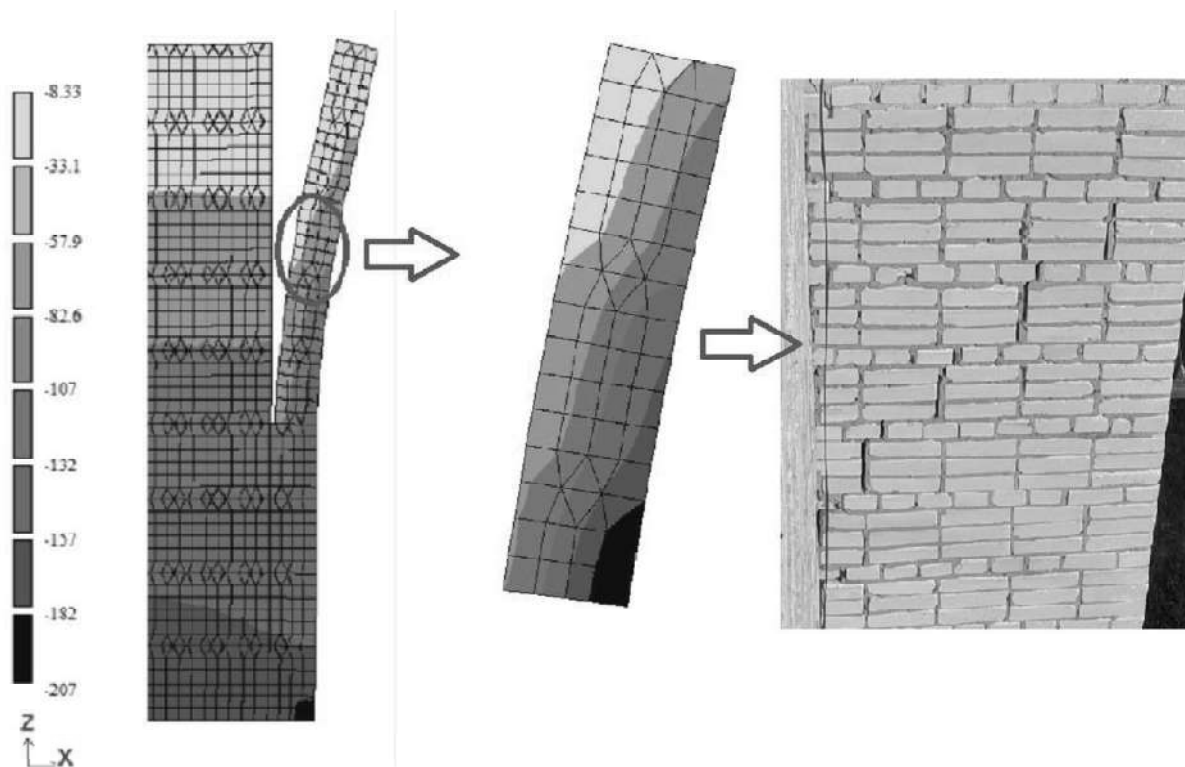
Fig. 4. Comparison of stress distribution N_y with a diagonal crack

A diagonal crack, which is located at the level of the 6th floor, is also fixed in the end bearing wall of the loggia (Fig. 4). The reason for this crack is that after the connection between the walls of the loggia and the walls of the house collapsed, the loggia began to deviate from the building, due to the fact that the facade of the loggia has constant running loads from reinforcing concrete wall panels and glazing.

(Fig. 4) shows the distribution of vertical stresses N_y , as well as the diagonal crack that cuts the brickwork at the seams.

External loads are applied to the facade of the loggia, which, in turn, due to the occurrence of a through vertical crack, leads to uneven stress distribution.

According to the comparison, the nature of the stress distribution corresponds to the nature of the development of the diagonal crack.
