A NEW LOOK ON PERIODIZATION OF PARTS OF MONUMENTAL ENSEMBLE OF THE ST. SOPHIA CATHEDRAL IN KYIV IN THE LIGHT OF THE LATEST STUDIES OF MOSAICS AND FRESCOS IN THE DOME-SPACE

Summary. The article deals with the results of the researches of mosaics and frescoes in the northern part of under-dome space of Saint Sophia Cathedral in Kyiv held during the conservation in 2013–2014. It revealed that the mosaic ornamental friezes' plaster on the north-western under-dome column covered fragments of frescoes that had existed on this pole before they were decorated with mosaics. During sensing and sampling plaster bases of mosaics in the northern under-dome space, the lower layer of fresco plaster was discovered under them in several places. This gave the rise to the conclusion that the mosaics in under-dome space are not the primary decoration, at least not all of them. On the first stage of designing the temple's interior the under-dome space was painted with frescoes to the top, which were later replaced with mosaics, although not completely. Considering such a conclusion, the fragments of fresco medallions of the Martyrs of Sebaste preserved on the western arch should not be considered as a

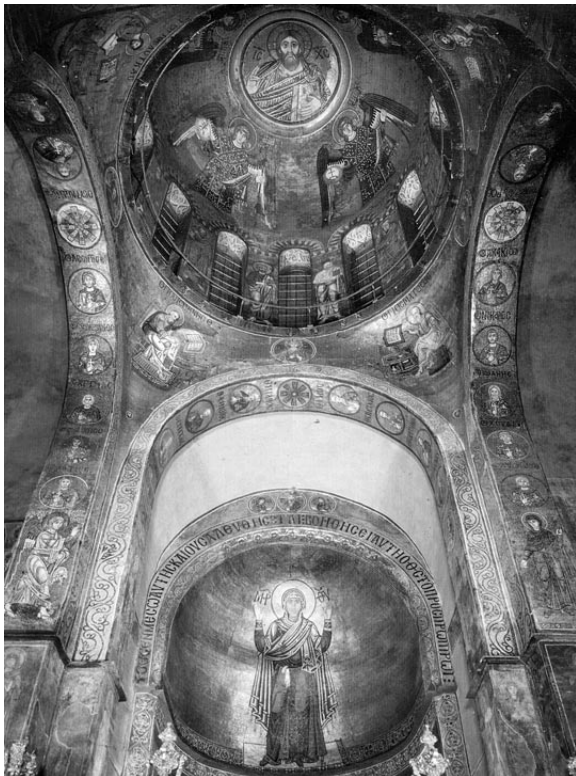
Лл. 1. The mosaic decoration of the dome, the under-dome space and the altar.

The core of dogmatic images' system of the St. Sophia mosaic ensemble is the waist-height image of Christ the Pantocrator in the central dome (fig. 1, 2.1). It is surrounded by four archangels.

1. The mosaic decoration of the dome, the under-dome space and the altar.
2. The cartogram of the position of mosaic in the dome, under-dome space, altar, and the remains of the frescoes in upper zone of the under-dome space and in the altar.

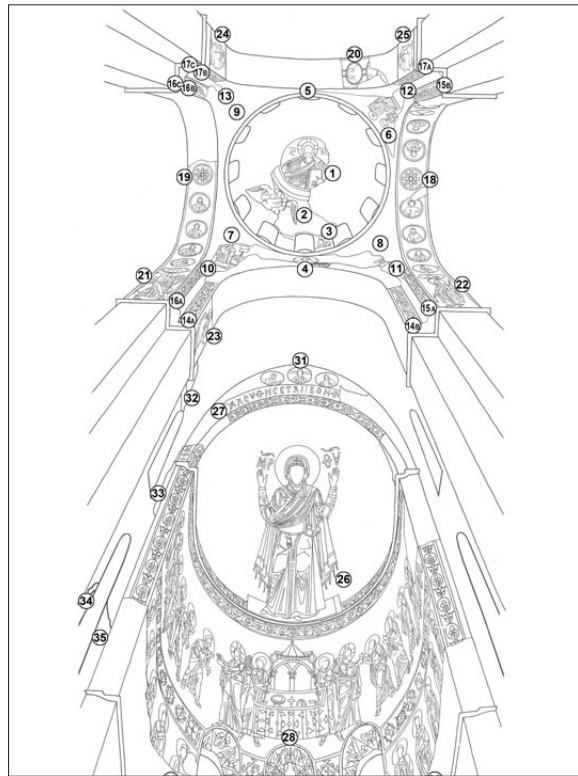
Лл. 2. The cartogram of the position of mosaic in the dome, under-dome space, altar, and the remains of the frescoes in upper zone of the under-dome space and in the altar.

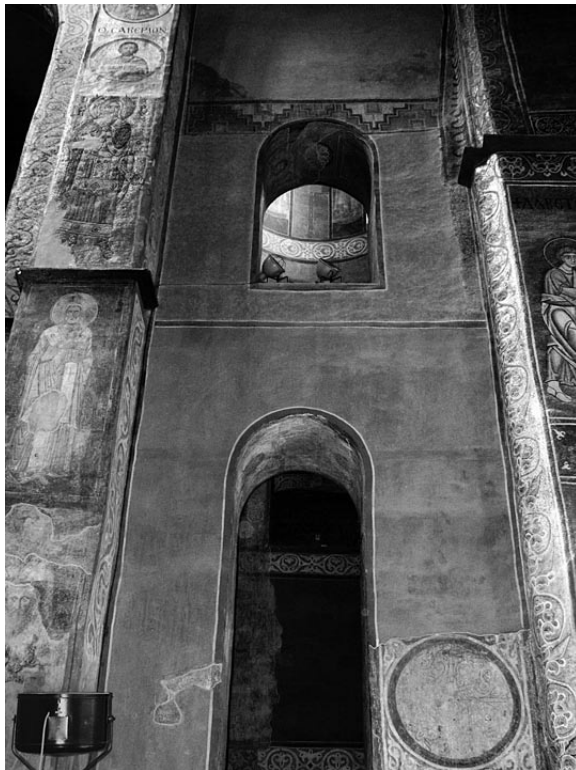
Лл. 3. The bema, the northern wall with fragments of mosaics in the upper part and frescos fragments in the lower part; the northern surface of the altar arch with the mosaic image of the high priest Aaron.

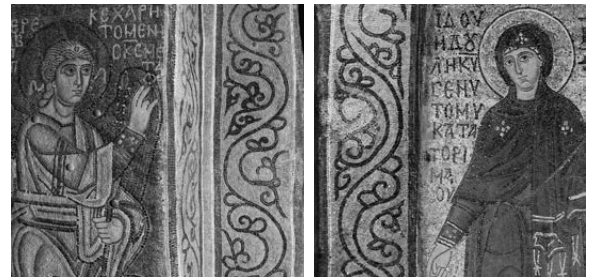
Лл. 4. The north-eastern pillar; the figure of Archangel Gabriel of the "Annunciation"; alongside on the southern pilaster of the pillar is ornamental frieze of the eastern under-dome arch.
Лл. 5. The south-eastern pillar; the figure of the Virgin Mary of the "Annunciation"; alongside on the northern pilaster of the pillar is ornamental frieze of the eastern under-dome arch.

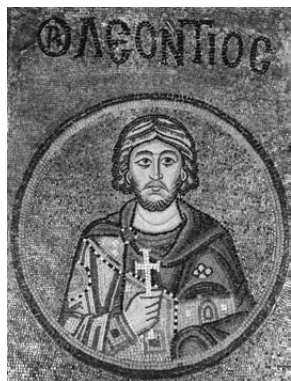
Лл. 6. The northern under-dome arch, eastern slope, the medallion with Leontius, the Martyr of Sebaste.

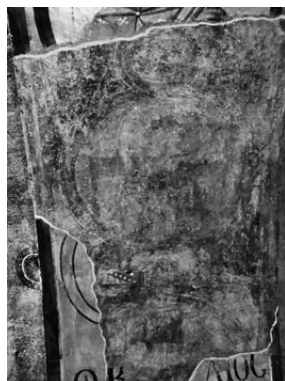
Лл. 7. The western under-dome arch, a fragment of a fresco with the remnants of two medallions with Martyrs of Sebaste.

2. Considering the first conclusion, the fragments of fresco medallions of the Martyrs of Sebaste preserved on the western arch (fig. 2.20, 7) should not be considered as an unfinished mosaic fresco ensemble complement (as V. Lazarev assumed [8, 38, footnote 4, 125; 9, 65]). They should be considered as the remains of the previous fresco paintings that were not replaced by mosaics.

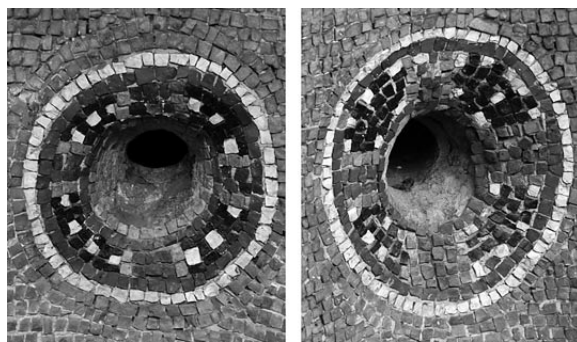
Лл. 8. The resonator holes: in the north-eastern pendentive (on the left); in the south-eastern pendentive (on the right).

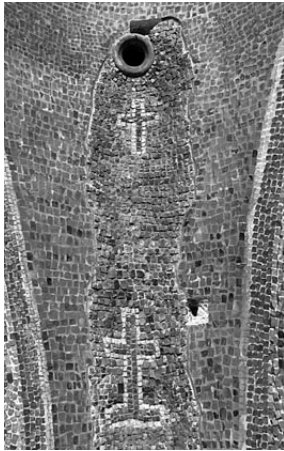
Іл. 9. The resonator hole and images of two crosses in the north-western pendentive

In 1989–1990 during prophylactic conservation of mosaics of the central dome and the under-dome space in St. Sophia (supervised by A. Ostapchuk), restorers noticed the significant differences in the design of resonator holes located in the pendentives. In the eastern pair of pendentives, both resonator holes are decorated with polychrome ornamental disks similar to plates (fig. 1, 2.10, 2.11, 8). Meanwhile, resonator hole in the south-western pendentive (fig. 2.12) is bordered by almost monochrome green-blue disc on a green background. In the north-western pendentive, the resonator hole is surrounded only by one row of white stones and one row of red cubes of smalt. However, the featured detail of the north-western pendentive is two small votive-like crosses below the resonator hole set in a red and blue smalt (fig. 2.13, 9).

Considering the above-mentioned differences in the design of the resonator holes in the eastern and western pairs of pendentives and no less significant difference in the fragments of ornaments preserved on the eastern and western pairs of pillars, the restorers expressed the point of view that the mosaic fragments in the lower parts of the western pair of pendentives (from the level of slightly higher than resonator holes) and the western pair of under-dome pillars belong to the latest phase of mosaic ensemble creation. However, the boundary between the sections of the earlier and the final phase of execution was not identified completely as the upper parts of the ornaments were lost on all arches, as well as a continuous loss observed over the resonator in the north-eastern pendentive (fig. 9).

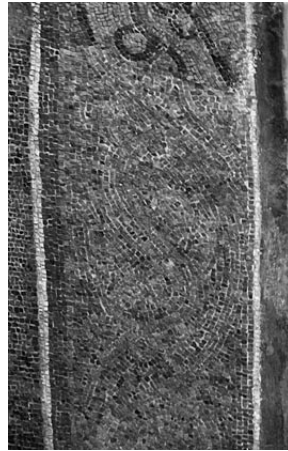
Іл. 10. The south-western pillar; the ornamental frieze of the western under-dome arch, the southern part.

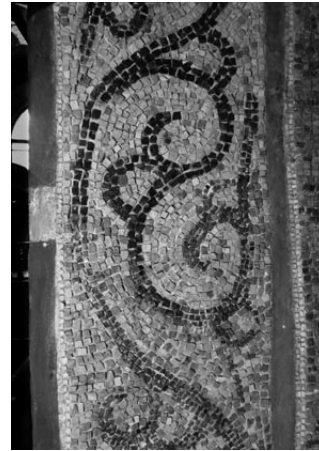
Іл. 11. The north-western pillar; the ornamental frieze of the western under-dome arch, the northern part.

ornamental frieze of the western arch located on this pillar, and for the stems mainly the emerald-black smalt is used there (fig. 2.15b, 13, 19). The northern arch frieze, in part preserved on the northeastern pillar, has a yellow background of the ornamental field as in the part of the eastern arch frieze located on this pillar, with the stems set in on a yellow background with a saturated green smalt (fig. 1, 2.16a, 14). The background of the ornamental field of the part of this frieze preserved on the north-western pillar filled with a colorful mixture of brown, green, dark-olive and light-olive shades of smalt supplemented with a light-grey stone in some areas. The stems in the upper part of this preserved area are set in with an emerald-black smalt, while lower part stems are of a pure black setting alternating with the blue one in some places. In the highest part of the fragment both background and stems are set in standard cubes for Sophia mosaics of 5x5, 5x7 mm. Meanwhile, beneath, the smalt is punctured irregularly with the mainly large-scale module (10x10 mm or bigger), the cubes are laid with different gaps, and, in general, the set looks negligently (fig. 2.16b, 15, 16). A similar large-scale module of smalt and rather negligent technique is the characteristic of the northern section of the frieze of the western arch located on this pillar (fig. 11, 18).

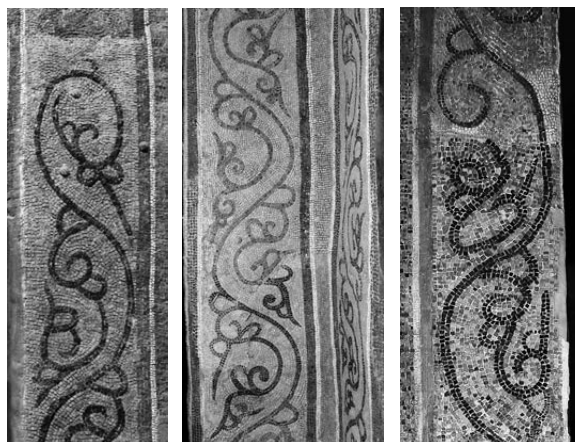
Лл. 13. The south-western pillar, the ornamental frieze of the southern under-dome arch, the western part.

Лл. 14. The north-eastern pillar, the ornamental frieze of the western under-dome arch, the northern part.

Лл. 15. The north-western pillar, the ornamental frieze of the northern under-dome arch, the western part.

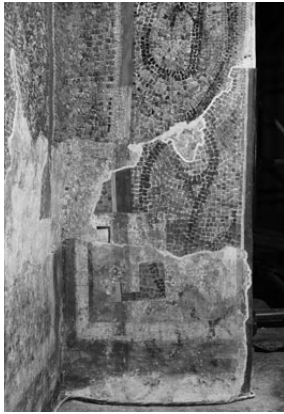
Лл. 16. The north-western pillar, the lateral facets of the eastern pilaster, the fragment of the fresco panel, partly covered by the mosaic ornamental frieze.

on the north-western pillar (*fig. 16 — 18, 22.№15F*). At the same north-western pillar, along with the edge of its eastern pilaster, the mosaic plaster intervene the remnants of the red ochre fresco-fringing of the lost image on the frontal facet of the pilaster (*fig. 22.№11M/F*). Regarding this, it is worth paying attention to the information of V. Lazarev, who wrote, referring to the study of restorers of the 1950s (no particular source was pointed out), that the mosaic decoration on the western slopes of the northern and southern under-dome arch was limited by their bases (lower medallions with images of the Sebaste martyrs), below which the pilasters on the pillars were painted with frescoes [9, 65]. Therefore, mosaic ornaments on the pilasters of the western pair of pillars appeared not only later than fresco figures under the western arch, but also later than frescoes that existed on the pilasters under the western slopes of the northern and southern arches. Now the frontal facets of these pilasters are covered with oil paintings on the plaster of the 19th century. During the sondage of the pilaster of the north-western pillar in 2013, the remains of the ancient plaster were not found. Another area with remnants of fresco plaster covered with a mosaic grout and set exists alongside the lower image of the cross located beneath the resonator hole in the north-western pendentive (*fig. 9, 22.№10M/F*). It evidences that not only the vertical parts of the pilaster, but also the pendentive were originally painted with frescoes, and their mosaics belong to the later phases of interior decoration. A few analogous places where the mosaics decorations covered the plaster of previous frescoes were also discovered on the south-western pillar (*fig. 22.№13M/F, №14M/F*).

was also used to set in the background of ornamental friezes on the north-western under-dome pillar, where it is supplemented with a few completely dark olive shades and a few lighter ones (fig. 11, 15, 18). Now we know that on the north-western pillar, the areas of these ornaments overlap the earlier frescoes (fig. 16–18,

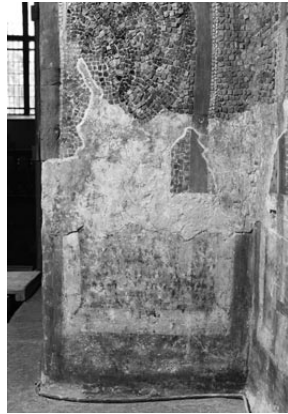
Лл. 17. The north-western pillar, the lateral facets of the southern pilaster, the fragment of the fresco panel, partly covered by the mosaic ornamental frieze.

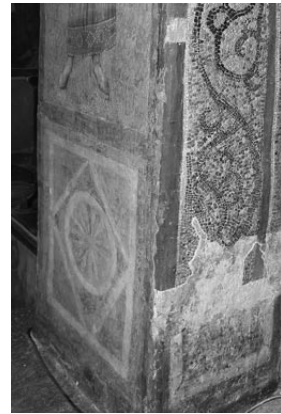
Лл. 18. The north-western pillar, the southern pilaster, the fresco panels on its frontal and lateral facets, the mosaic ornamental frieze on the lateral facet partly overlaps the fresco panel below.

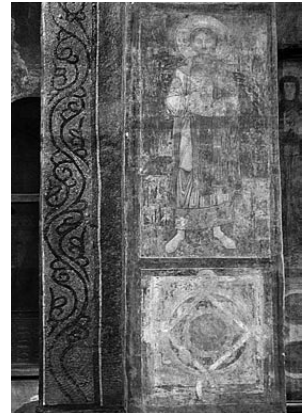
Лл. 19. The south-western under-dome pillar, the north pilaster, a fresco figure of an unknown martyr and a panel below it.

The frontal facets of the symmetrical pilasters on the south-western pillar also preserved the figure of the martyr and the panel underneath (*fig. 2.25, 19*). Mosaic ornamental friezes on the lateral facets of the pilasters of this pillar also do not reach the cornice. During sondage of over-paintings covering the areas with the missing mosaic set, on both pilasters, the insertions of the late plaster were revealed under the paintings. This plaster adjoins from above a mosaic plaster with

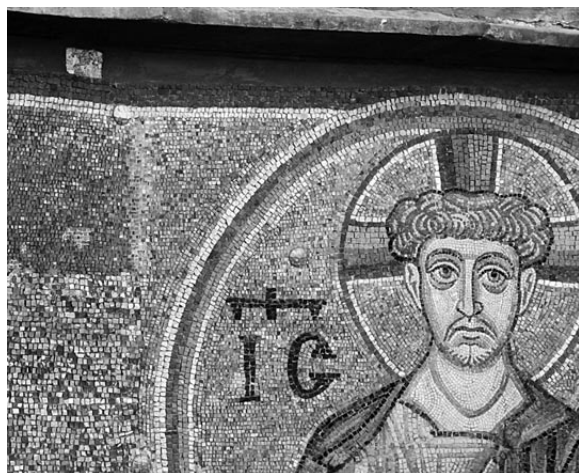
Іл. 20. The under-dome ring, the medallion over the eastern arch with image of Christ the Priest. A light rectangle below the cornice is probe with the remnants of the fresco plaster.

the mosaic plaster, were discovered (fig. 20, 22.№16F). This is obviously the remnants of the previous frescoes of the under-dome ring. Before being replaced with mosaics, they were put down. However, they partially preserved under the cornices, where the removal of the plaster basis was complicated.

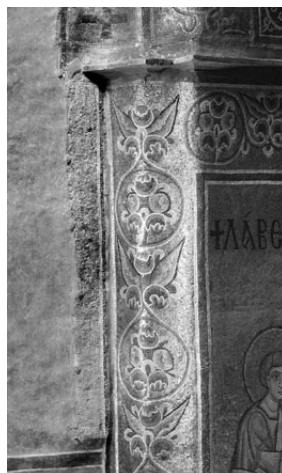
Іл. 21. Bema, the northern wall, the fragment of a mosaic with an underneath and a background, near with the mosaic ornament on the apse ledge.

2013–2014 restoration works did not cover the altar bema space. However, from scaffolding installed in the altar arch, it was observed that one of mosaic fragments preserved on the northern wall of the bema near the apse ledge (fig. 2.33) was set in with a smalt of a slightly larger module than the smalt of ornamental frieze on the apse ledge next to it. Moreover, on the part of the background of this fragment, an olive smalt was set instead of a traditional gold one. This feature was overlooked by V. Lazarev, who, about this fragment, wrote that over the yellow and green strips of its underneath "the remnant of the golden (our selection) background had been preserved" [8, 94]. In reality, smalt on the background of the fragment is of an olive-grey tint (fig. 3, 21), similar to the one set in a background of the ornamental friezes on the south-west under-dome pillar (fig. 10, 13, 19). The same smalt

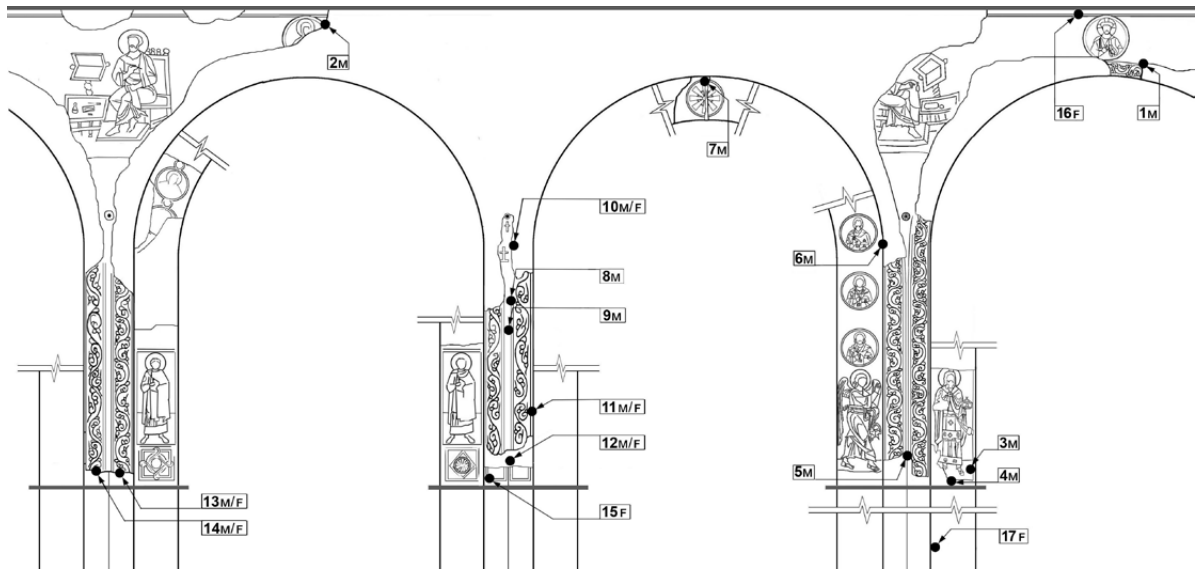
Лл. 22. The cartogram of the samplings of mortars of mosaics and frescoes plasters in the under-dome space in 2014 (after the sample number, the index "M" — a mosaic plaster, the index "F" — a fresco plaster, the index "M / F" — mosaic mortar, which overlaps the bottom layer of fresco mortar).

22..№11M/F-12M/F). Consequently, it arises an idea that the mosaic fragment located near the apse ledge, being the remnant of the lower case of bema mosaic images, may also belong to a later stage of decorations when mosaics replaced a part of the preceding bema frescoes. Though, to confirm this assumption, detailed studies of all non-examined bema walls are required.
