EMERGENCY CONDITION OF LOGGIAS IN BUILDINGS WITH SUPPORTING BRICK WALLS

A real example of such a problem in the existing 9-storey building with brick load-bearing walls, where the shortcomings of construction were manifested, namely the poor quality of masonry at the junction of loggias to the load-bearing walls of the building.

All these construction errors, individually or in combination, often lead to damage or destruction of the load-bearing structures of loggias, which, in turn, makes the building an emergency. An example of such a situation is the condition of loggias in an existing building with load-bearing brick walls on the street. Volodymyra Velykoho, 44 in the city of Lviv.

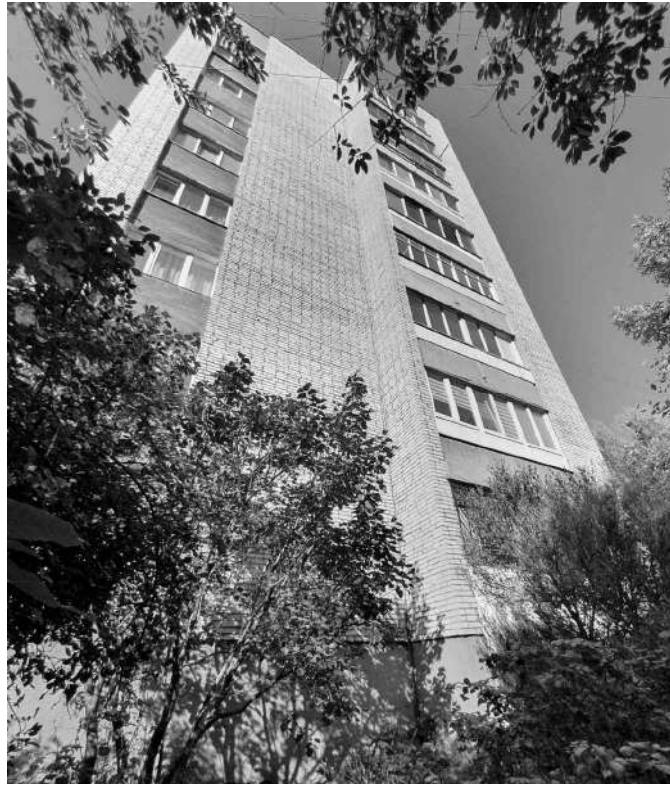
Fig. 1. Scheme of the building

Structural scheme of the building, part of which was inspected, with longitudinal and transverse brick load-bearing walls and horizontal overlapping disks. Residential building (Fig. 1).
