A CASE STUDY OF BRACED EXCAVATION USING STEEL SHEET PILE WALL IN THI VAI SOFT CLAY

The paper presents a case study of braced excavation using sheet pile wall in Thi Vai soft clay in South East of Ho Chi Minh city, Vietnam. The study is focused on stress-strain-displacement behavior with field monitoring of lateral displacement of the wall and settlement of the surrounding area while the 11m excavation of the pump pit was performed. Furthermore, comparison of calculated and monitored data is shown to get insight into actual behavior of the braced cut wall. It is finally found that the ratio between maximum lateral displacement to maximum excavation depth ranging from 1.12, 3.08 and 3.35% respectively for inclinometers INC-01 to INC-03 and that between surface settlement to maximum excavation depth 0.93% without any failure of the braced excavation and effective stress analysis can be used for getting reasonable and practically accepted values of both lateral displacement and surface settlement.

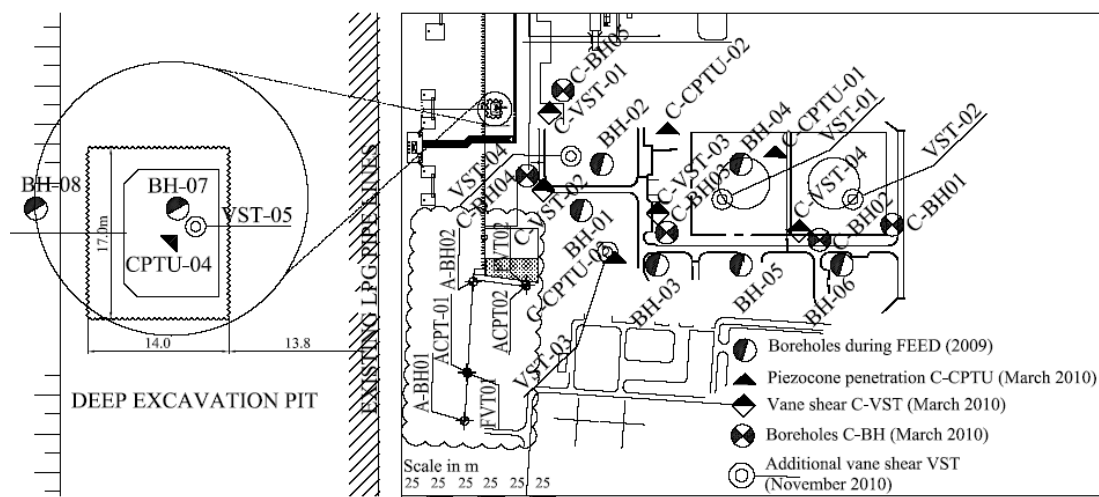
Fig. 2. Layout plan of soil investigation for the project site

Sandy soil was found in boreholes BH-07 and BH-08 from the depth of 20 to 27 m though its thickness is ranging from 18 to 25 m for the whole site. Fig. 2 shows the layout plan of soil investigation in the river water intake area. Fig. 3 shows physical-mechanical property profiles which clearly separate two layers of soft soils in the ground. The soft clay has natural water content close to liquid limit, unit weight of around 15.0 g/cm^3 and void ratio ranging from 1.7 to 3.20.

Fig, one piezocone penetration test CPTU-04 and one field vane shear test VST-05 was conducted just for the engineering design of this support structure before the start of the excavation work to get undisturbed samples for laboratory testing and good insight into the real soil condition of the reclaimed soil after ten years. The additional soil investigation is necessary for the design and construction of the braced excavation in soft ground condition. The ground includes around 2 m of sand filling on the top, which was completed around ten years ago, underneath is 18 m of soft clay with high water content and highly compressible characteristics.

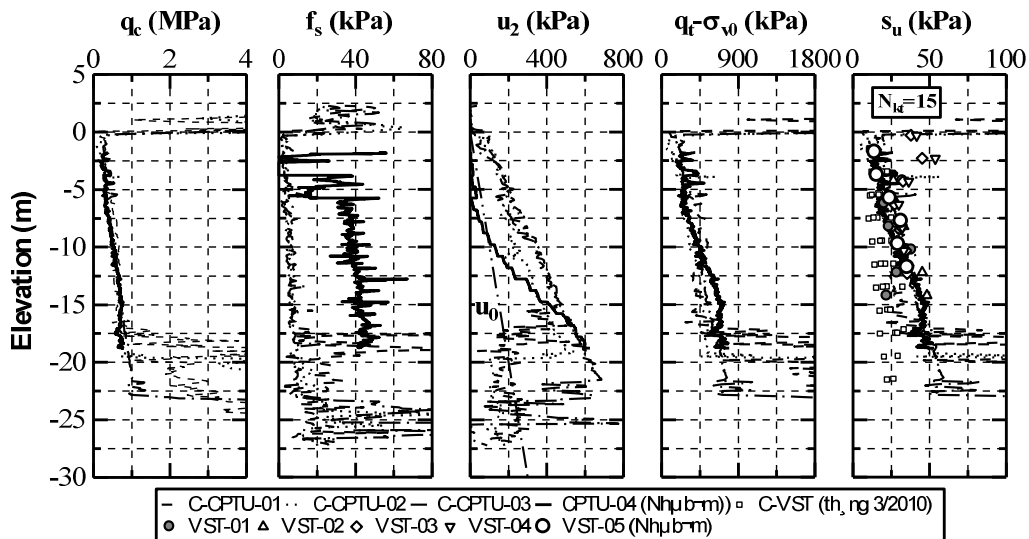
Fig. 4. Piezocone penetration and field vane shear test results

The field testing results by piezocone penetration and vane shear test plotted in Fig. 4 shows that the soft clay is almost same from top to bottom of the soft clay layer though there is sand seam found from elevation -1.0m to -5.0m with high undrained shear strength at shallow depth as presented in Fig. 5.

Furthermore, the increase in $(q_t - \sigma'_{v0})$ in these depths confirm the existence of these sand seams. As found in the laboratory test results, un-drained shear strength to effective over-burdened stress ratio is of 0.23 as the average value according to vane shear test and piezocone penetration as shown in Fig. 4 and Fig. 5. Moreover, cone factor $N_{kt} = 15$ is found to be consistent with vane shear test data. Soil properties for each layer are tabulated in Table 2.

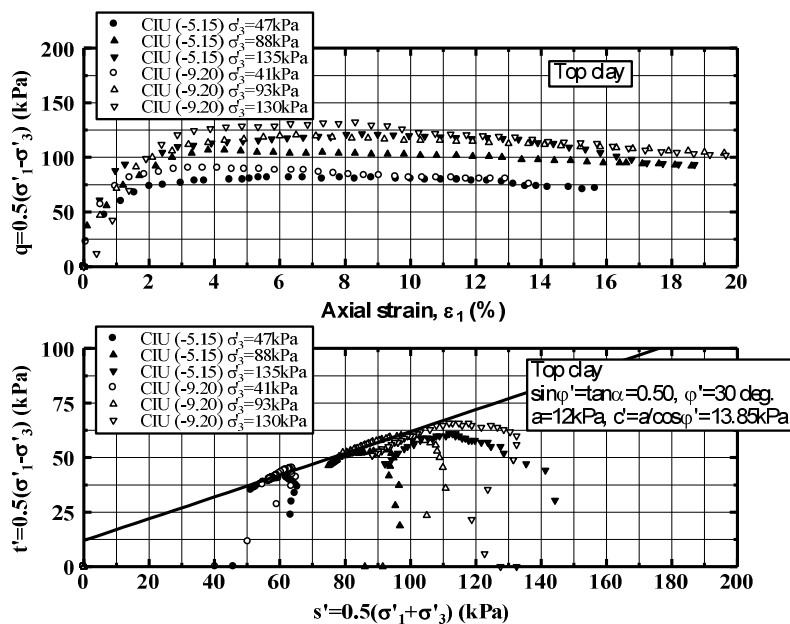
Fig. 6. Triaxial test results for top soft clay

There were six samples taken by hydraulic piston sampler for UTCT (Undrained Triaxial Compression Test) as presented in Fig. 6 and Fig. 7 to be done to get effective stress parameters for the analyses, vane shear test and piezocone penetration test are used in conjunction with UTCT for the estimation of the effective stress parameters of soft clay layers.

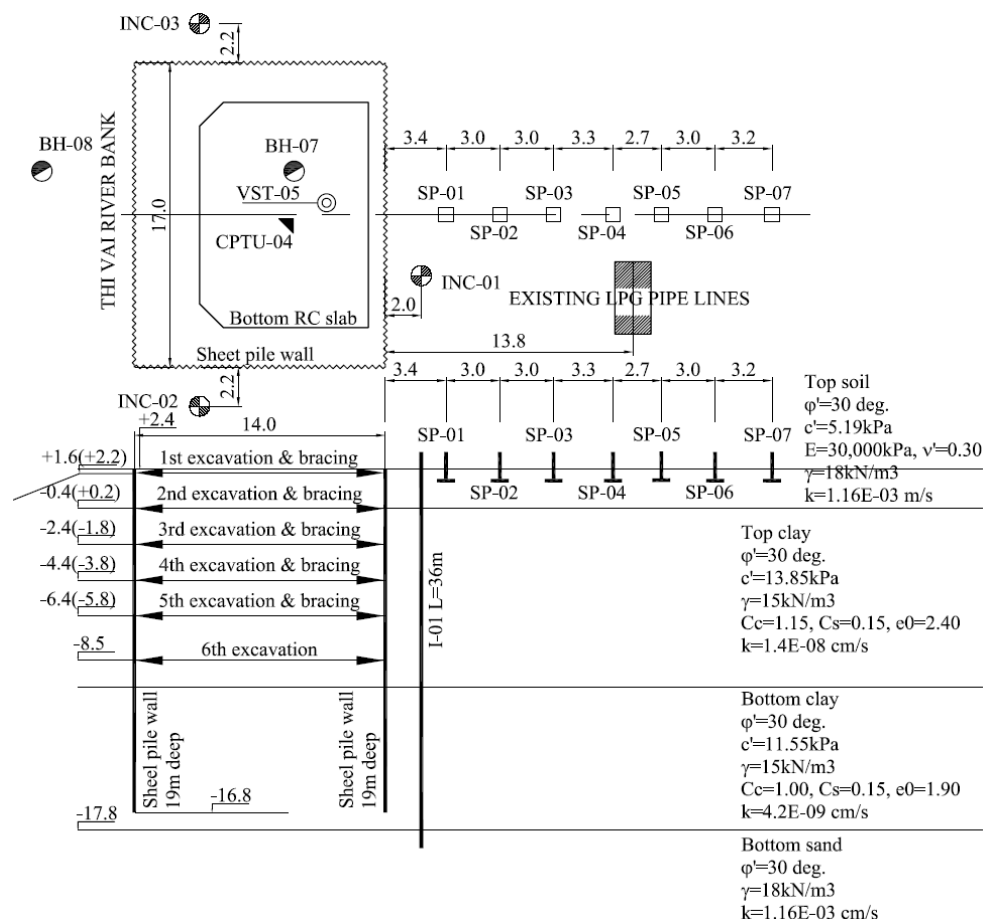
Fig. 8. Arrangement of monitoring instrumentations (Dimension in m)

Monitoring instrumentations. For the safety control of deep excavation, field monitoring instrumentations including settlement plates from SP-01 to SP-07 and inclinometers from INC-01 to INC-03 were installed following the arrangement in Fig. 8 and data were used for the evaluation of behaviors and safety factors of the excavation work. In the mean while, there are existing LPG pipelines, which need to be secured, about 13.80 m from the sheet pile wall.

As shown in Fig. 8 three inclinometers were installed around 2 m away from sheet pile wall line in order to avoid their damages during the installation of sheet piles. The main direction of inclinometer INC-01 is toward riverside or toward the excavation pit while INC-02 and INC-03 directions are toward riverside and toward the excavation pit. This arrangement gave the engineers the overall view of lateral movement of earth into the pit and toward the river because one side of the pit is close to Thi Vai River. In this case, it was very important to use inclinometers INC-02 and INC-03 for the assessment of factor of safety for land sliding issues too.

However, in this paper only data of inclinometer INC-01 is used for assessment of behavior of soft clay under braced excavation of the pit. Inclinometers and settlement plates were installed before sheet pile were driven by hydraulic pressing machine so the initial readings for these instrumentations will be determined as from the completion of sheet pile installation on 06 December 2011. The length of inclinometers installed is of 36 m; however, the data considered are only 30 m from the top of inclinometer casing. Top elevation of the casing is almost equal to existing ground elevation.

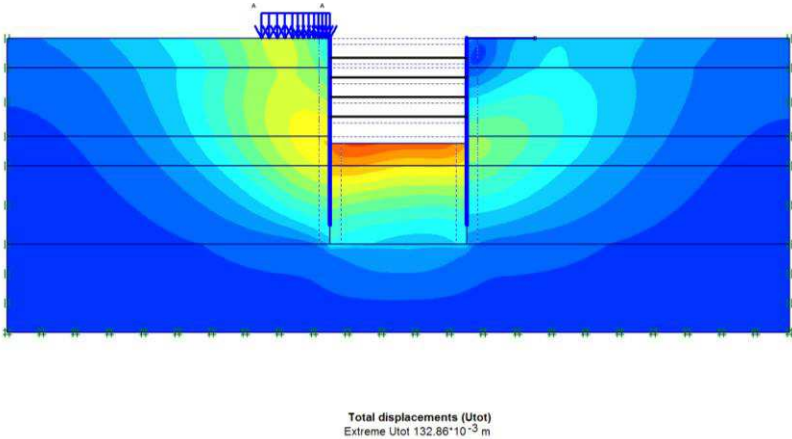
Fig. 11. Shaded displacement at 6th excavation

Finite element analysis with soft soil model is performed, under plane strain condition, to evaluate the behavior of the wall compared to field data. The results of FEA are presented in the below section. Fig. 11 and Fig. 12 show shaded total displacement and deformed finite element mesh of the whole domain after the 6th excavation. The maximum uplift movement of bottom of excavation pit is around 127 mm as shown in Fig. 13. The uplift movement is increasing from sheet pile face to center of the excavation pit. However, outward of the pit, there is ground loss behavior and the ground loss at pit bottom elevation is ranging from 3 mm to nearly 41 mm at 6 m from sheet pile wall. The total uplift

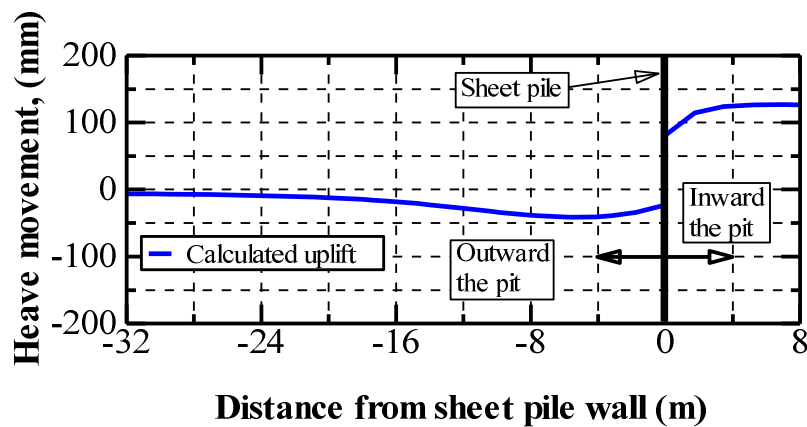
Fig. 13. Uplift at bottom of the excavation pit

movement here can be attributed to rebounding of soft clay and large lateral displacement of sheet pile.

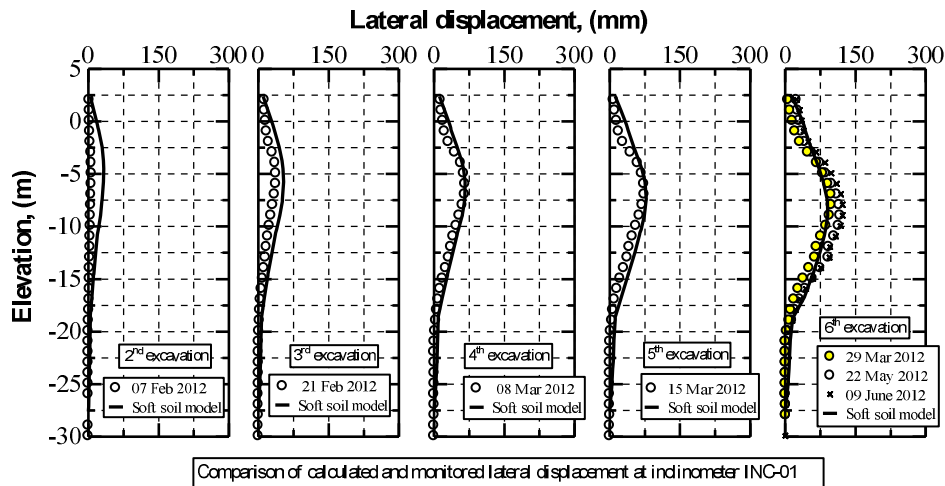
Fig. 14. Comparison of calculated and monitored lateral movement at inclinometer INC-01

The results of lateral displacement vs elevation and surface settlement vs normalized distance from the wall are plotted in Fig. 14 and Fig. 15 right at the end of each excavation stage. Calculated lateral displacement and surface settlement show good agreement with monitored data. However, the monitoring data show that after the date of the last excavation on 29 March 2012, lateral movement and surface settlement was still increasing, this can be attributed to consolidation and/or degradation of modulus of highly compressible soft clay, which is not considered in this paper. The authors found that for practical purposes, an effective stress analysis with Soft Soil model in a finite element code can achieve good results for both lateral movement and settlement in comparison with actual monitoring data. From 3rd to 6th excavation stage the results of the analysis show that calculated values are well agreed with monitored values of lateral displacement. At the 2nd stage, calculated lateral movement of inclinometer is larger than monitored values, and the monitored values from the 6th excavation are increasing over time.

The ground calculated loss profiles are well agreed with the monitored data as specified in Fig. 15. The differences at lateral movement may be attributed to over-cutting of earth at some areas in the excavation pit, resulted in actual excavation depth was larger than that considered in finite element analysis.

To this end, even the lateral movement is ranging from 1.12 – 3.35% maximum depth of excavation, there is no signal of failure during the construction of this braced excavation. Furthermore, it was found that at the end of 4th and 5th excavation, there was twisting of bracing beam at level 4 and 5 from the top so lateral displacement increase aggressively. However, lateral movement of sheet pile has been stopped from 22 May 2012 to now because drastic action was taken as soon as there was evidence that the lateral movement of sheet pile was increasing more and more.
